Document Title	List of known Issues of Secure Hardware Extensions
Document Owner	AUTOSAR
Document Responsibility	AUTOSAR
Document Identification No	971
Document Status	published
Part of AUTOSAR Standard	Foundation
Part of Standard Release	R23-11

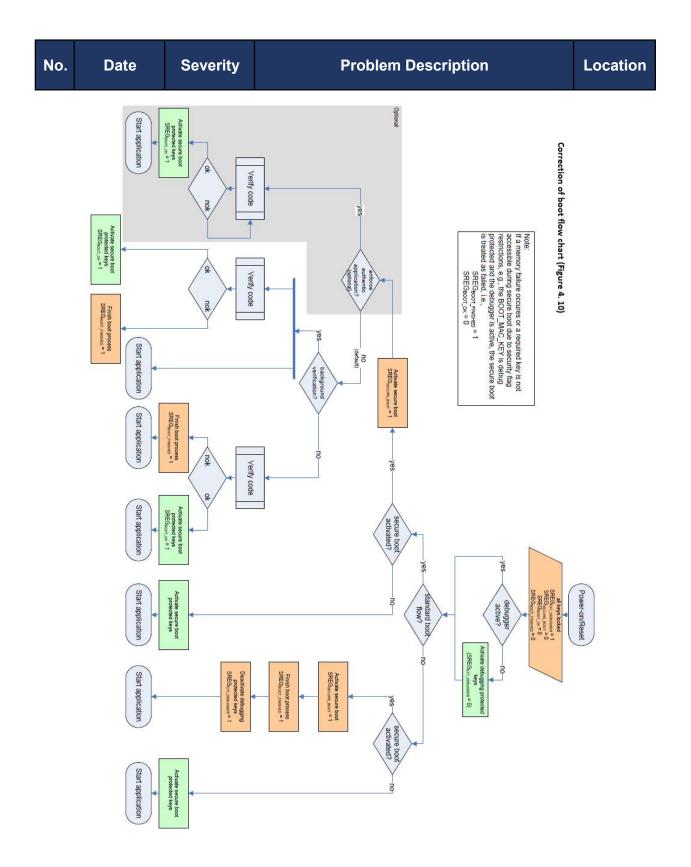
No.	Date	Severity	Problem Description	Location
1	2009-07-31	erratum	CMD_EXPORT_RAM_KEY can also issue error code ERC_KEY_NOT_AVAILABLE.	Section 4.7.9 Table 4.6
			Note: The description of the command and the overview table were missing the information.	
2	2009-07-31	erratum	CMD_GET_ID may not issue error code ERC_KEY_NOT_AVAILABLE since key protection flags are not evaluated	Section 4.7.17 Table 4.6
			Note: The description of the command and the overview table indicate an error code that cannot be emitted by the command.	
3	2009-07-31	erratum	CMD_EXPORT_RAM_KEY reads UID Note: The command also needs to access the UID to calculate the messages. The referenced table is missing the corresponding information (X = used by function).	Table 4.4
4	2009-07-31	erratum	The flag SREG.EXT_DEBUGGER has not to be set if the secure boot failed, see Figure1 of this errata sheet for a corrected flow chart.
